Geologic Assessment

GEOLOGICAL ASSESSMENT FOR U. S. 281 FROM LOOP 1604 TO BORGFELD ROAD, BEXAR COUNTY, TEXAS

6 December 2010

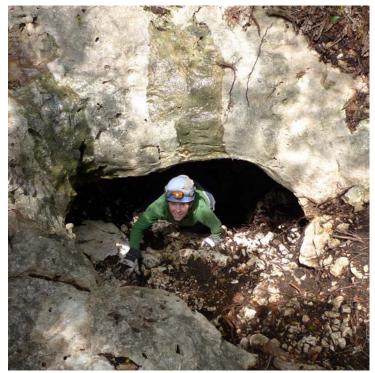
Caption: Surveyor exiting Taco Truck Tunnel (feature 281-025) during excavation.

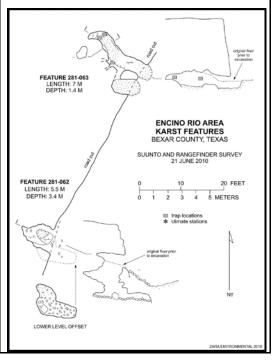
This cave is in the road cut on the west side of US 281, south of Encino Rio. It has two entrances at the base of the road cut that were initially 0.5 m (1.6 ft) wide. The northern entrance could be seen to extend 2 m into the road cut and continued on. It contained infill of leaf litter and organic sediment. It was excavated on 3, 14, and 23 June 2010. These excavations resulted in the removal of 3 m³ of material from the feature. The resulting cave is 7 m (23 ft) long, with a small connection between the two entrances that is not humanly passable. Each entrance is 1 m (3.3 ft) wide and both passages drop below the level of the roadway shoulder to a depth of 1.4 m (4.6 ft). The south entrance quickly rejoins the main passage in the north section. The cave ends in a flowstone wall.

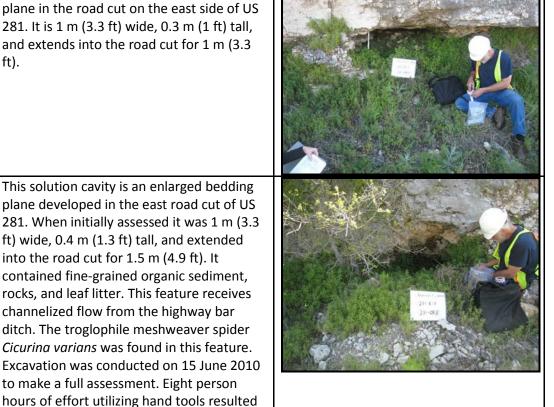
This solution cavity is an enlarged bedding plane in the east road cut of US 281. The entrance to the feature is 0.5 m (1.6 ft) wide and 0.3 m (1 ft) tall. It extends into the road cut for 1 m (3.3 ft). It contains smooth bedrock walls with no infill material.

voids visible.

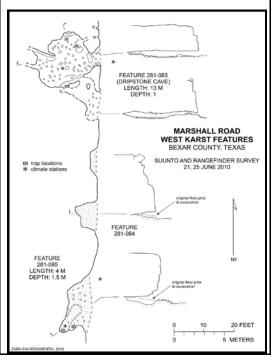
This solution cavity is located on the west side road cut of US 281, to the south of Marshall Road. It is formed in an enlarged bedding plane. When initially assessed the entrance was 1.3 m (4.3 ft) wide and 0.35 m (1.1 ft) high, and it extended over 1.5 m (4.9 ft) into the road cut. The passage made an 80 degree turn to the right beyond which it could not be examined. It was evaluated via excavation on 18 June 2010. Using hand tools, 1.25 m³ (44 ft³) of material was removed with 9.5 person hours of effort. This enlarged the feature to 3 m (9.8 ft) in width, 1.25 m (4.1 ft) in height, and extending just over 2 m (6.6 ft) into the road cut. No continuing voids existed.

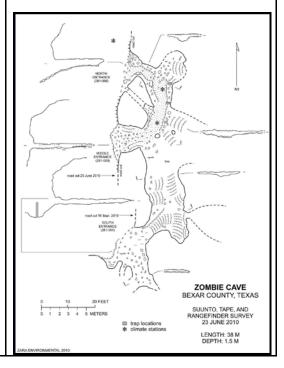
(Zombie Cave) This karst feature is located in the road cut just south of Zombie Cave, and upon excavation and investigation was found to connect to it. See the description of 281-088 for more information.
